Forest  
Practices  
Board

# *Audit Process and Woodlot Trends*

*Presentation to FBCWA Conference  
September 30, 2016 – Prince George*

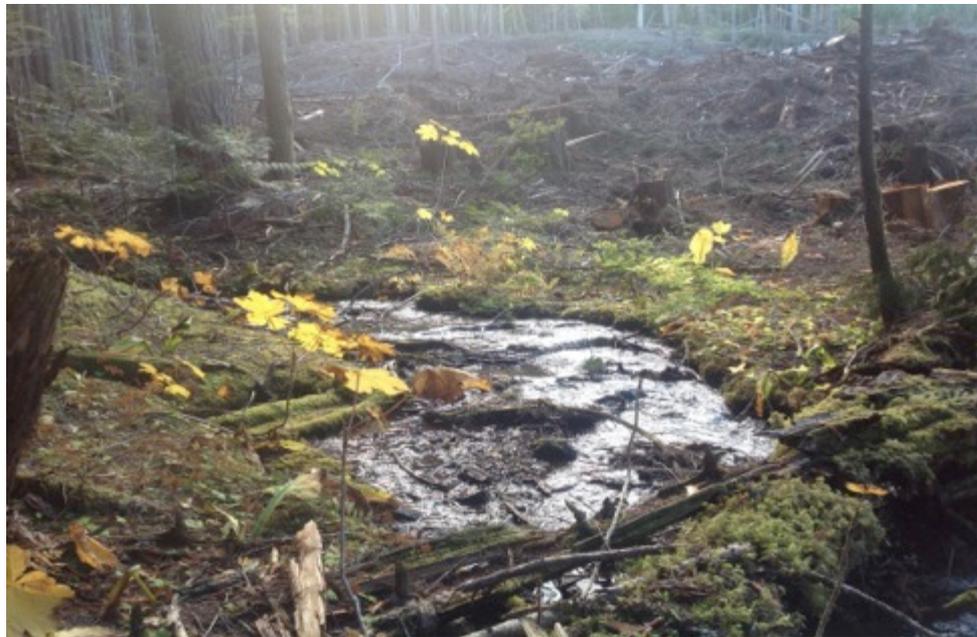
Practice Example – Non-compliant

Here is an example of a lack of riparian management.

The RRZ has been logged for a 40m length of the stream.

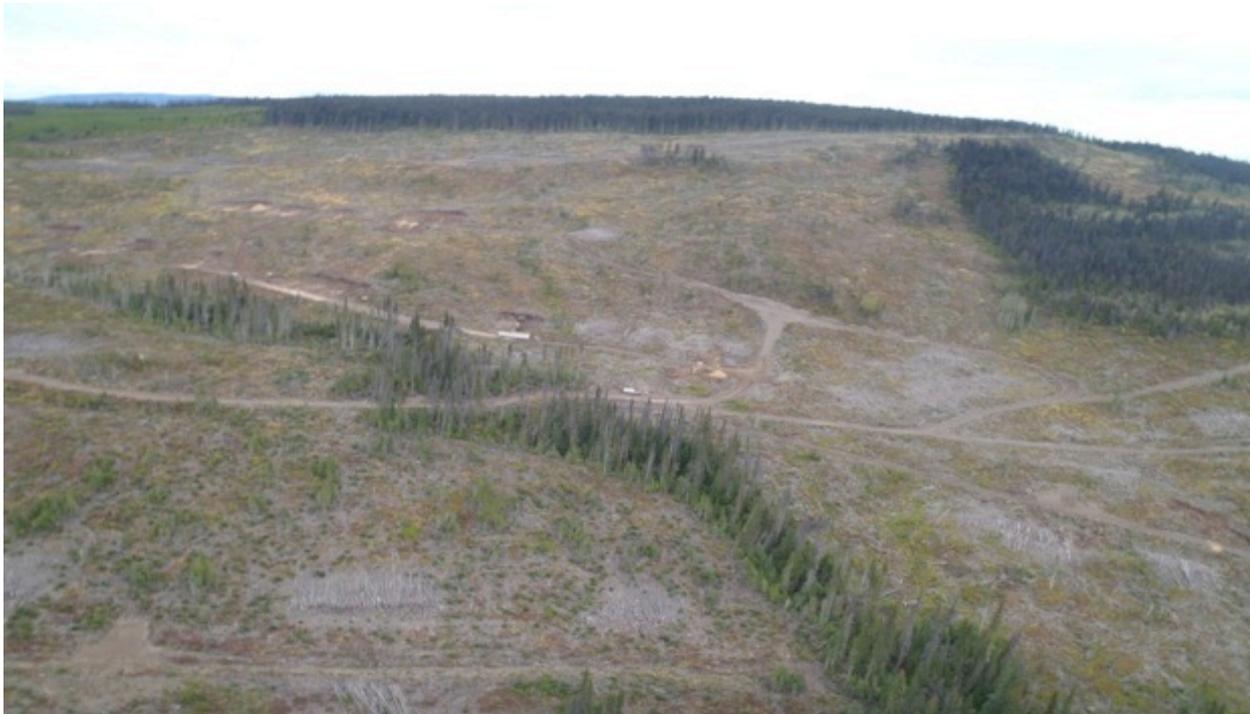
Practice Example - Compliant

An example of good riparian management.

This stream is machine buffered with good vegetation retention.

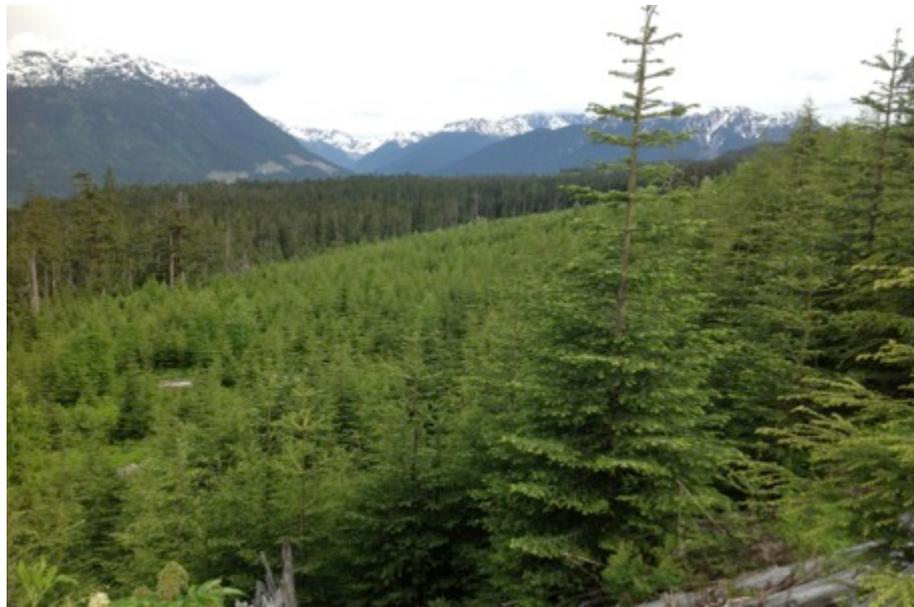
Practice Example - Compliant

Silviculture is another important practice we assess  
Here is a nicely regenerated stand that meets  
stocking standards.

But not only do we want to see this – we need to  
ensure the correct seedlings were used on the site.

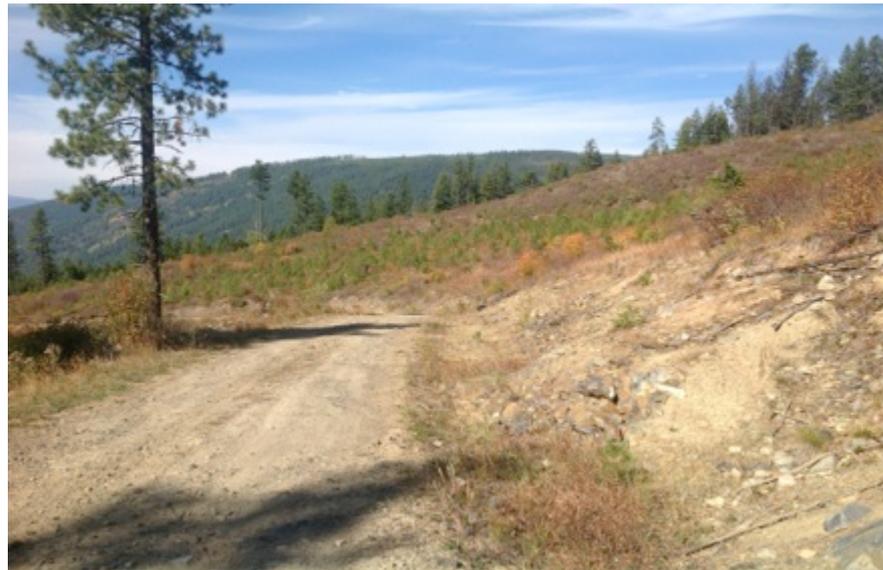
Practice Example – Non-Compliant

Here is a poorly regenerated stand that does not meet stocking standards at regeneration delay – foreground an ridge had no trees.

RESULTS information did not reflect the condition of this stand – no surveys, forest cover or regen delay.

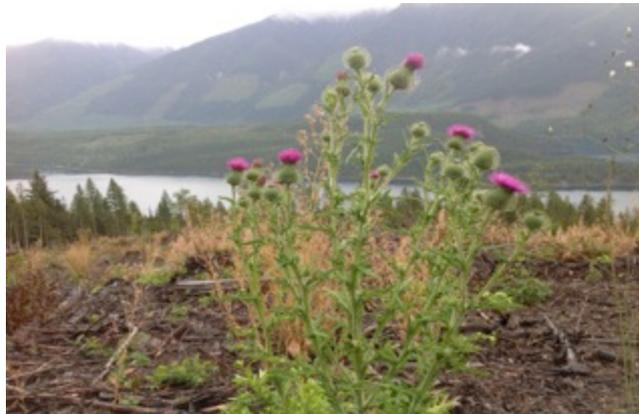
The control of invasive plants is another important practice we assess.

- Are they monitored?
- Are they reported to an invasive plant committee when encountered?
- Have exposed soils been seeded to limit further establishment?
- Is the seed mix appropriate – ecologically sound and does not contain other invasive plants – use forage mix?

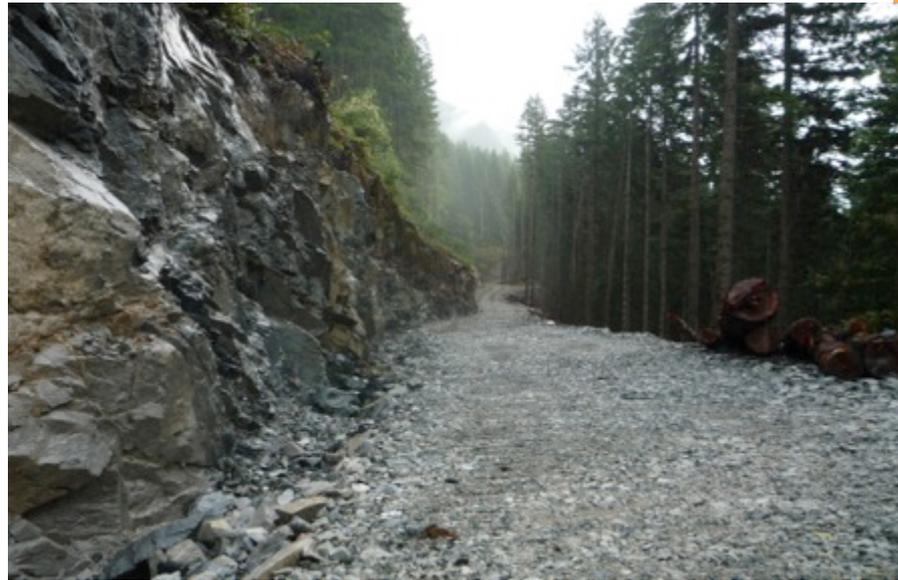
Practice Example - Compliant

Here is a well constructed and maintained road in very difficult terrain.

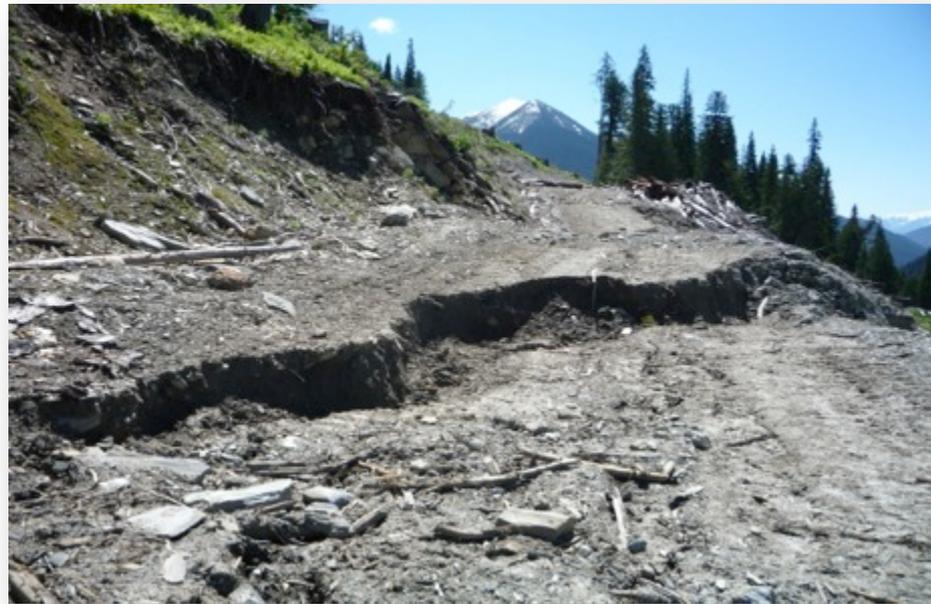
Here is an example of a Road prism failure – road was only 3-4 years old, built improperly resulting in large tension cracks with a high probability of continued failure.

No ditching or water management was noted. So once again, don't forget about the water.

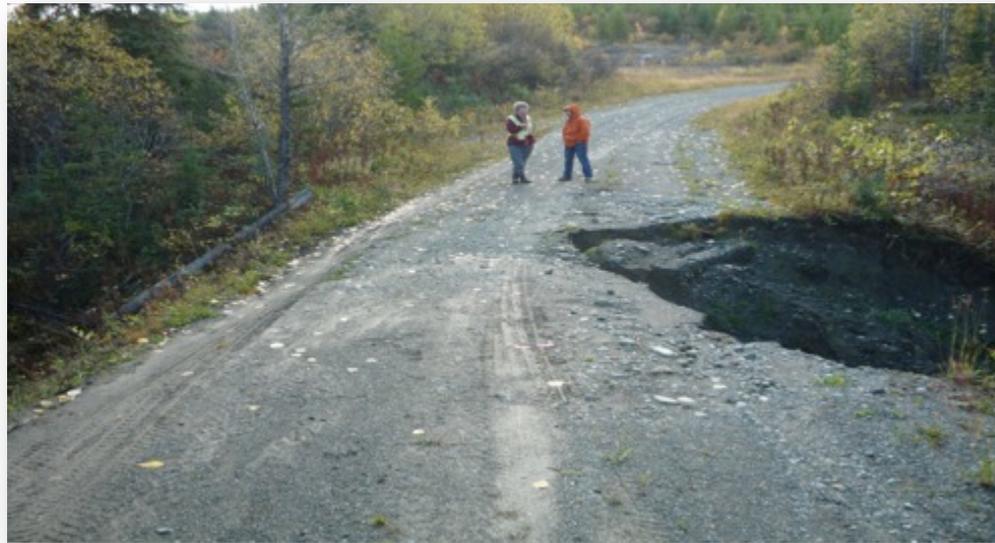
Road Maintenance – failure of a road prism. Road under permit but considered a wilderness road. Still utilized by public. No warning signs and failure of the culvert below introduced sediment into an S4 fish stream.

Board would have like to see some flagging around this hole and a plan in place to fix this issue.

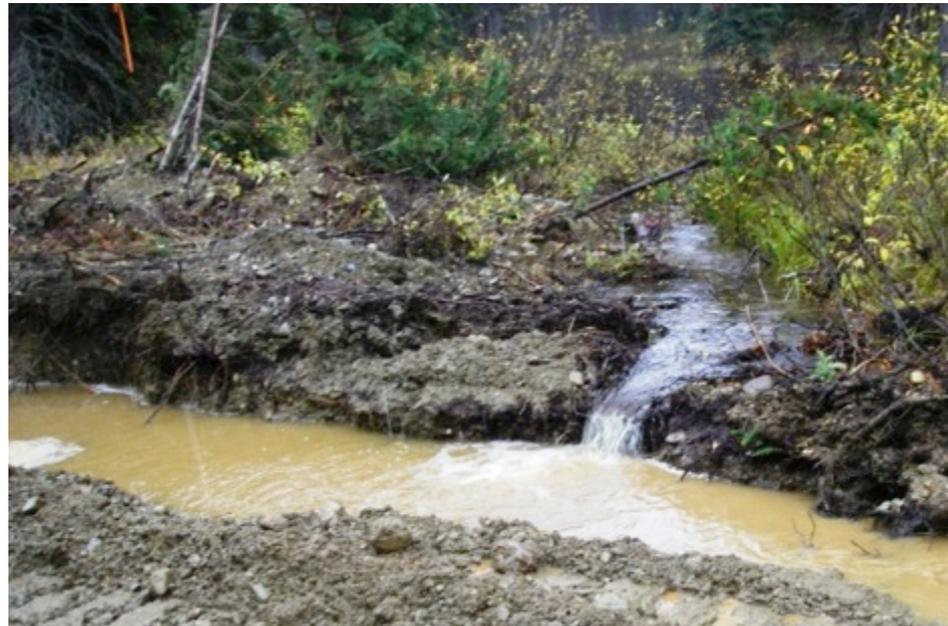
Practice Example – Non-Compliant

Road Construction – legislation states you must maintain natural drainage patterns both during and after construction.

That didn't happen here! Road construction created a new outlet to this pond.

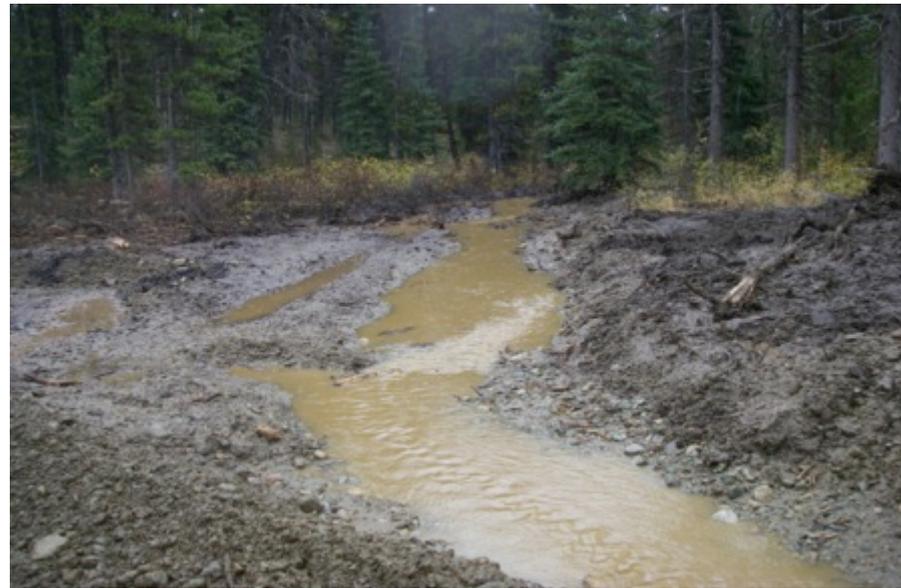
Practice Example – Non-Compliant

The resulting sedimentation flowed down the “road” into the brush and into a fish stream.

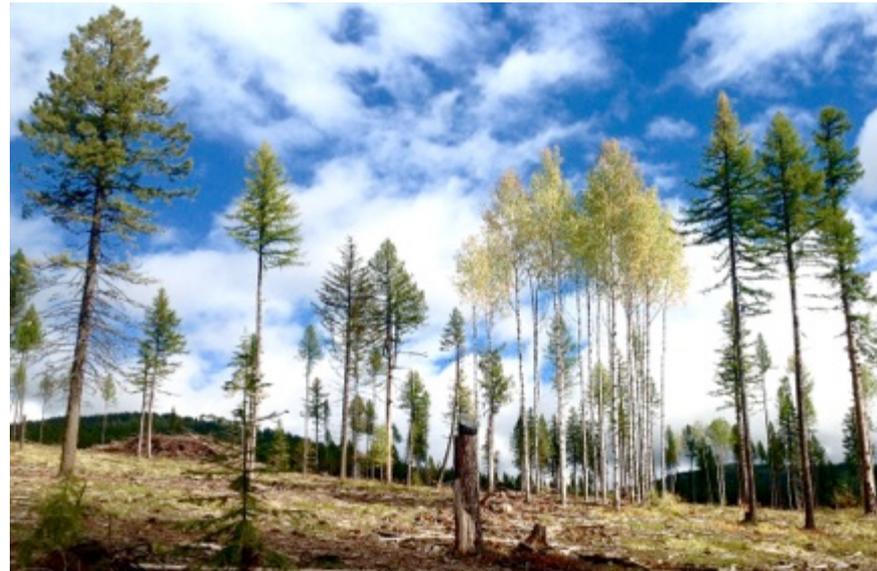
Here is an example of Harvesting with dispersed retention. Good adherence to plan and acceptable soil disturbance levels.

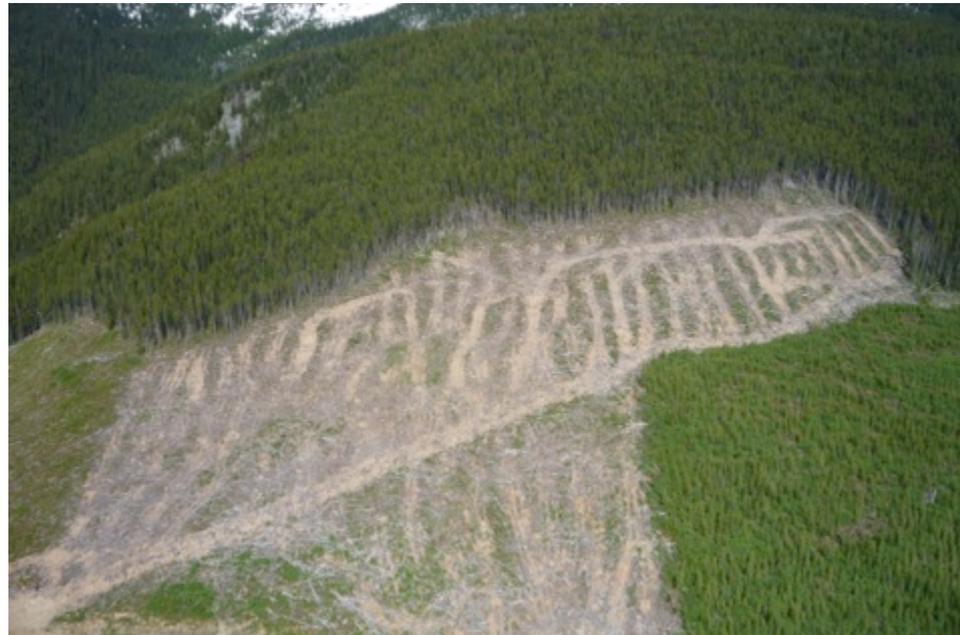
Practice Example – Non-Compliant

And here is a harvesting example of “what not to do!” Very high levels of site disturbance within a cutblock. An example of not using the right tool for the job – here an operator did not adhere to the site plan and used a skidder when cable harvesting was prescribed.

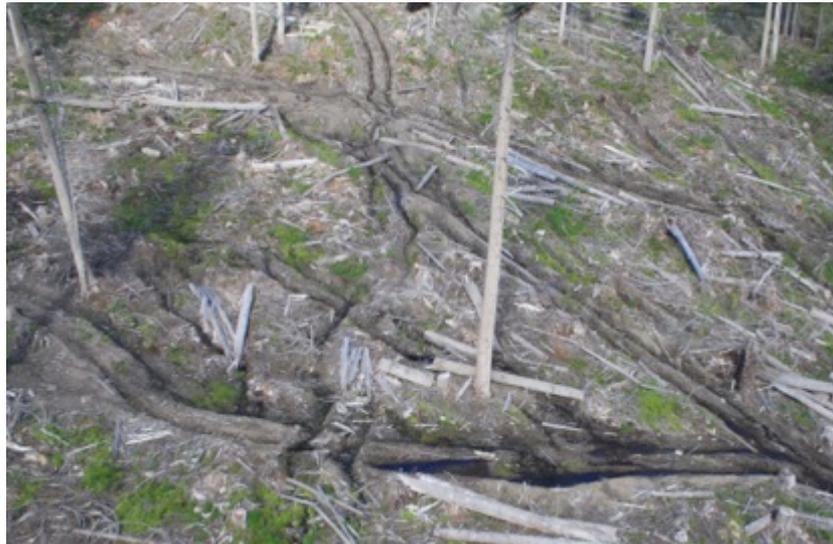
Practice Example – Non-Compliant

More very high levels of site disturbance within a cutblock.

The good thing was they saw the mess they were making in this wet soil, so they pulled out and came back when it was dry to finish logging and rehabilitate this block.

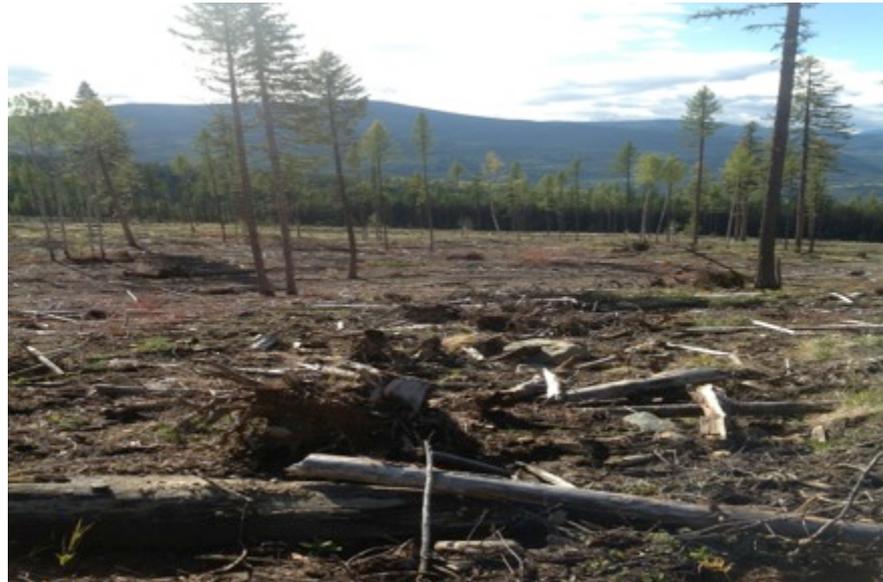
Practice Example - Compliant

A good example where, on sensitive soils, the logger used designated skid trails and rehabilitated the trails after harvesting.

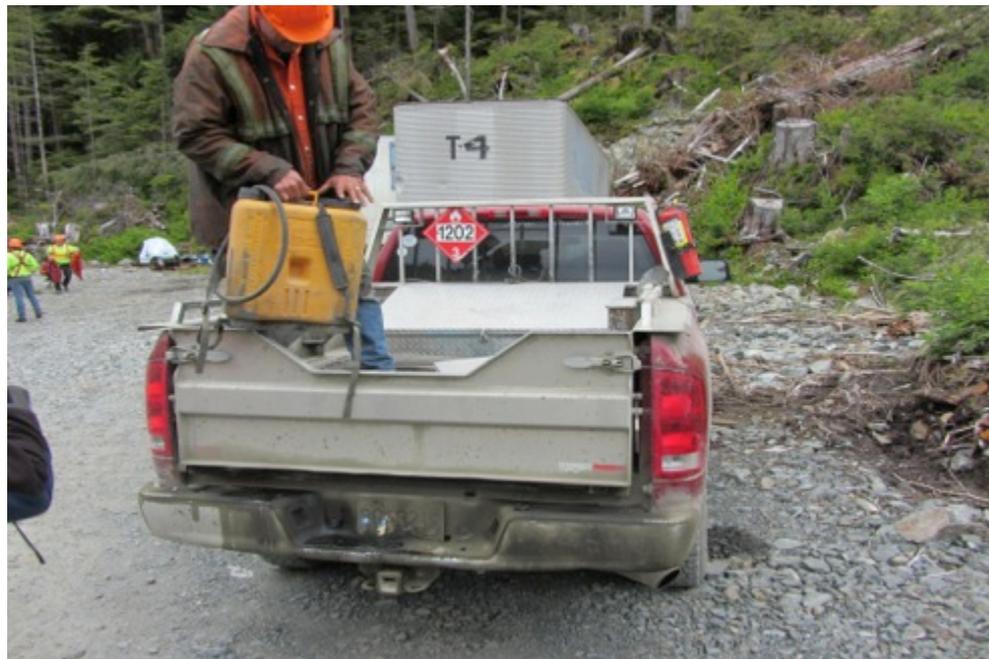
We check whether adequate fire tools are on site and that operators adhere to fire restrictions.

And whether a fire suppression system is ready to be used should a fire occur. In this case because the tank is empty and the nearest water supply is over 2 km away – the suppression system is not adequate.

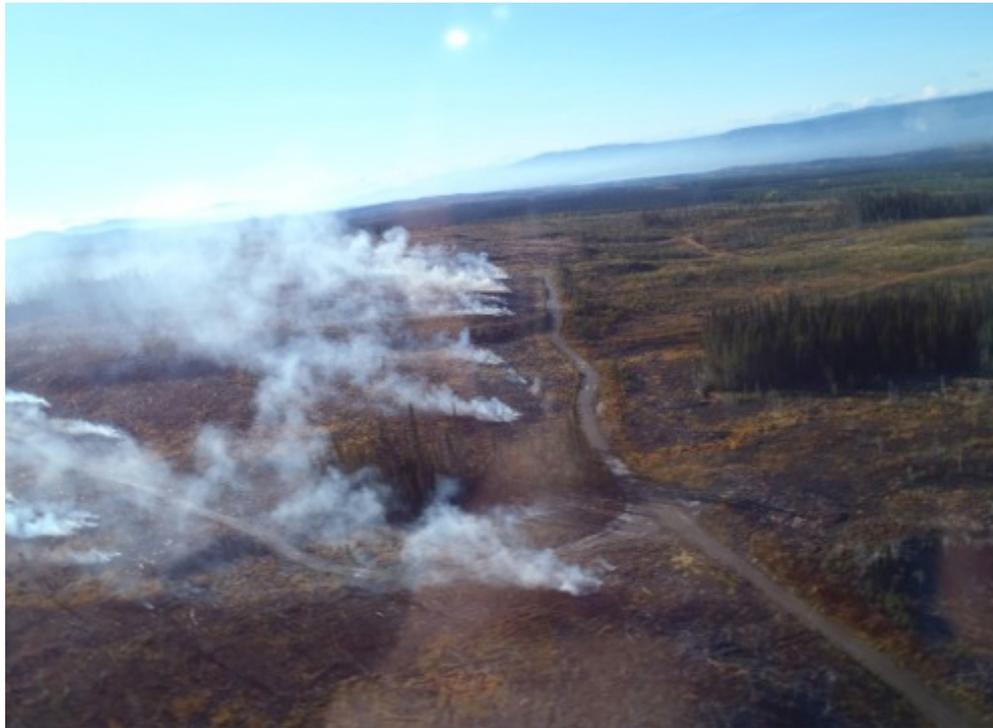
An example of slash burning in progress.

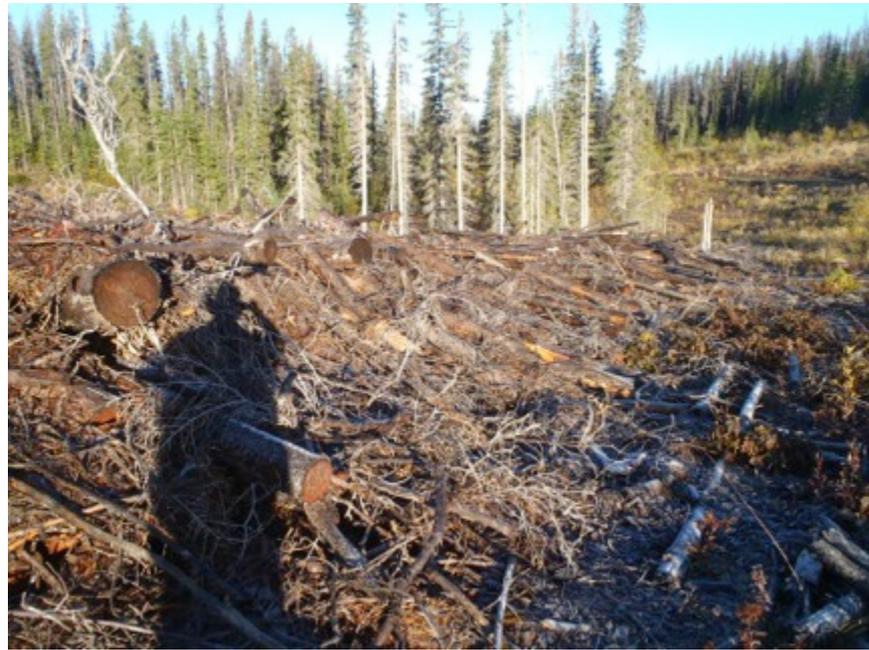
An example where slash burning is a few years overdue and now, due to slash decomposition, it will be difficult to get a good burn and there is a high risk to damaging the adjacent timber if burned and planting has been delayed by several years.

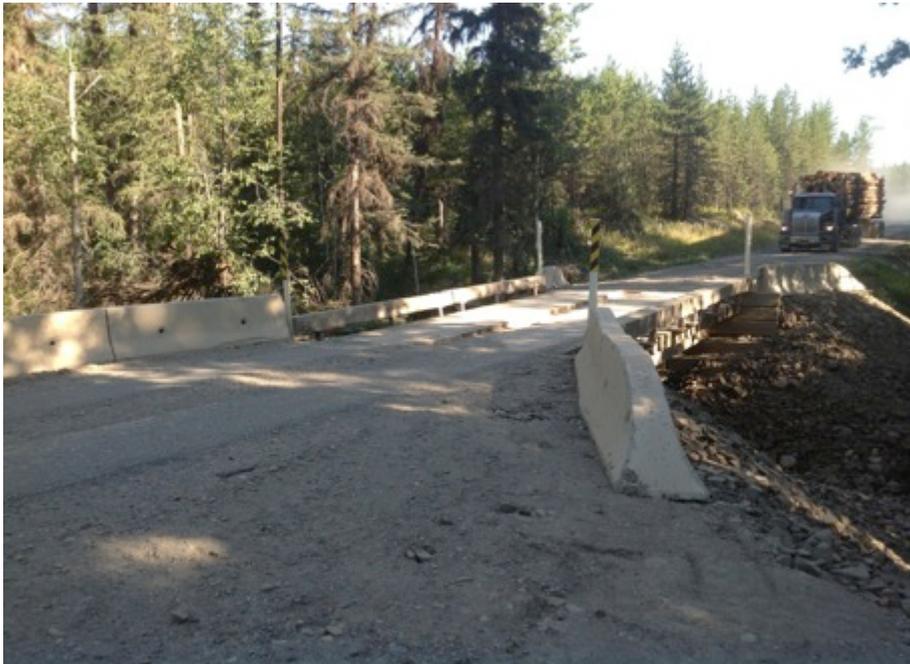
Practice Example - Compliant

Here is an example of a well constructed bridge.

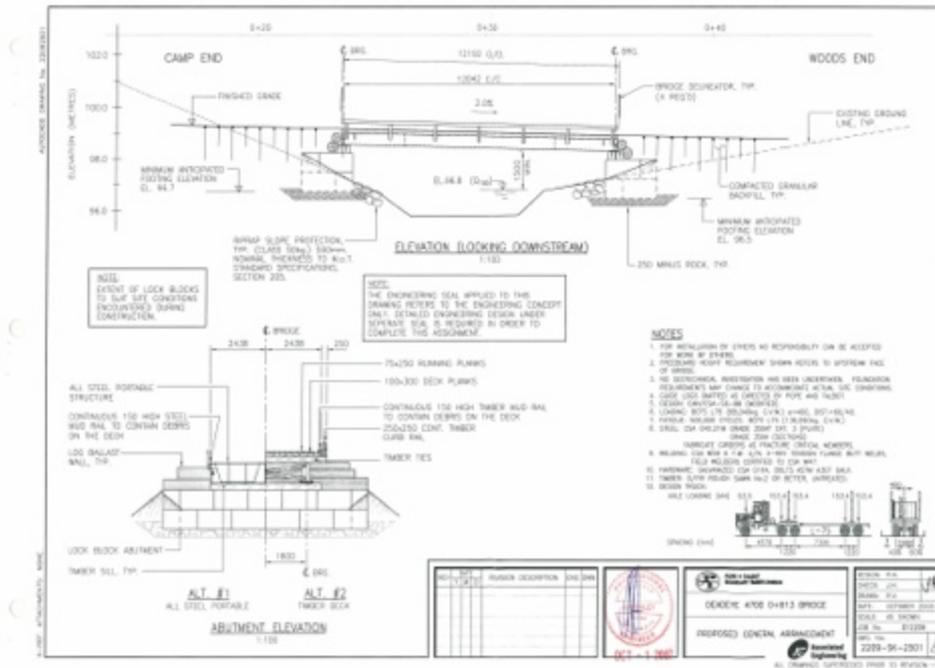
Practice Example - Compliant

Here is an example of a well designed “General Arrangement Plan”. As auditors, prior to going out to the field we ask for copies of such plans and correspondence. This generally gives us a better idea of what to expect.

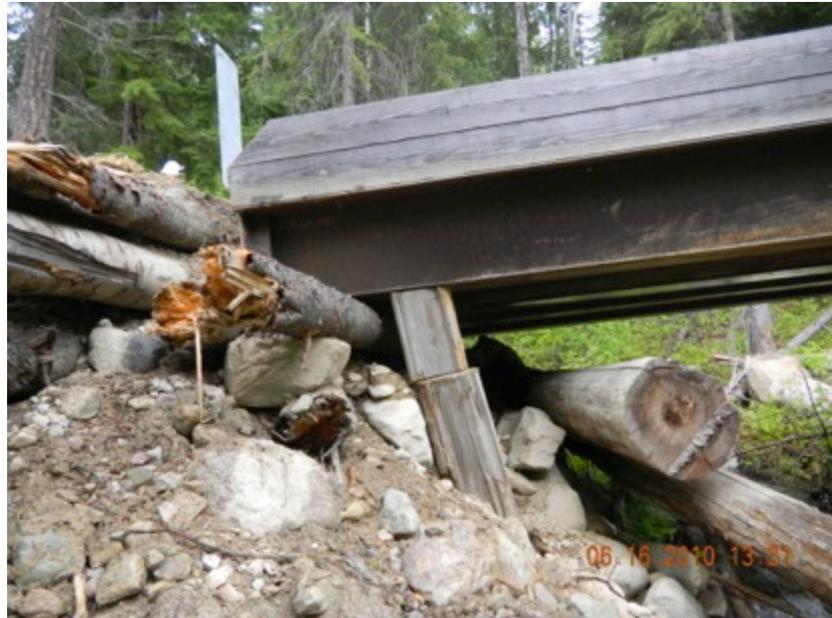
Practice Example – Non-Compliant

However, here is the finished product of the previous plan.

- 12m steel portable. Licensee claimed the ground was too frozen to properly excavate to establish a base for the substructure
- Bearing on un-compacted, loose soil and randomly placed logs.
- Rounds used to prop up downstream side on panel as it was settling.

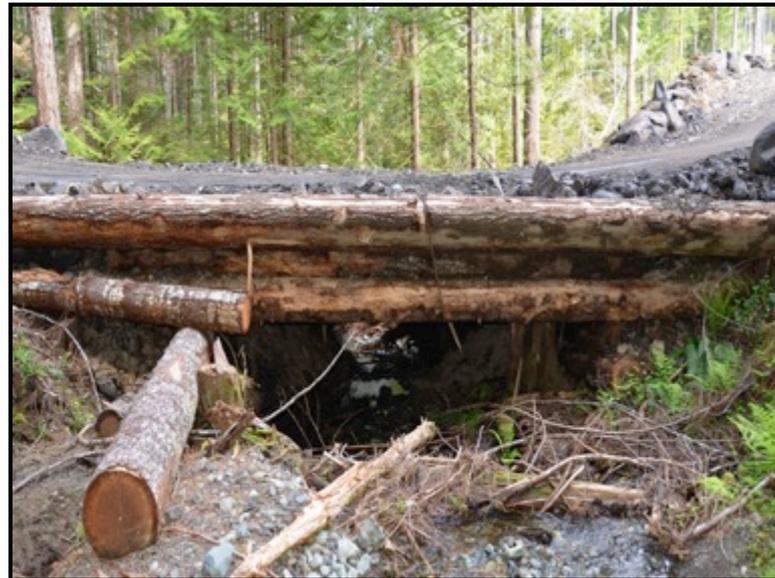
Practice Example – Non-Compliant

This is a poorly constructed bridge - Bridge located at the bottom of a hill, on a curve and there are no guard rails. Superstructure was not lashed or pinned properly to the foundations. No consideration for unbalanced loads or off-centre driving.

The auditee said they were building a culvert so didn't need a plan. However, this is over 6 metres, therefore a bridge.
